# A Remote Data Collection Journey: The Auroville Language Laboratory

Daniel Lago Leal

Transsolar Academy 6

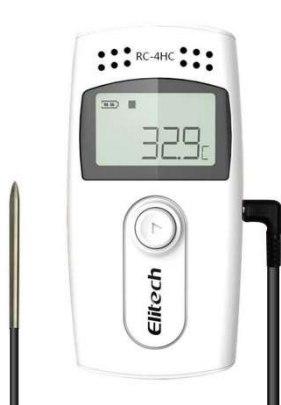
**Figure 1** Elitech (RC-4HC) and air temperature probe (left)

Consistently with the above mentioned, the Auroville Language Lab staff was able to purchase six Elitech branded devices, model RC-4HC. In addition, a FLUKE 59 MAX Thermal Gun was acquired to analyze the thermal performance of surfaces within the building.

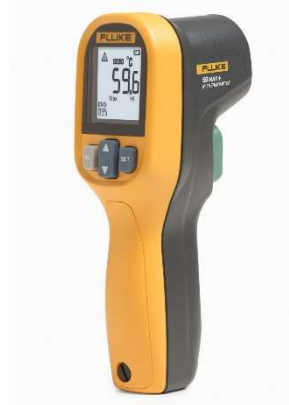
**Figure 2** FLUKE (59 MAX) thermal gun

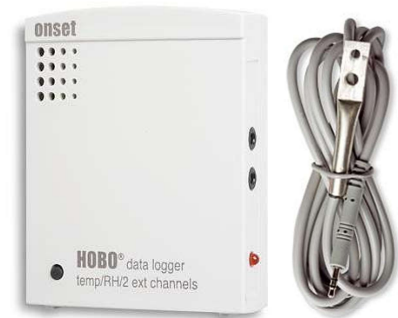
**Figure 3** HOBO Onset (U12-013) air temperature / humidity data logger and (TMC6-HE) surface temperature sensor

A request for support made to the Auroville Scientific Research Center (CSR) was not ignored. The CSR kindly lent eight HOBO Onset data loggers, model U12-013, technologically superior compared to Elitech devices. The possibility of connecting two external sensors, in addition to the default ones, as well as the user-friendly interface for their configuration are key reasons to validate this affirmation. This institution also provided seven surface temperature sensors, model TMC6-HE, of great importance to collect a larger volume of data.

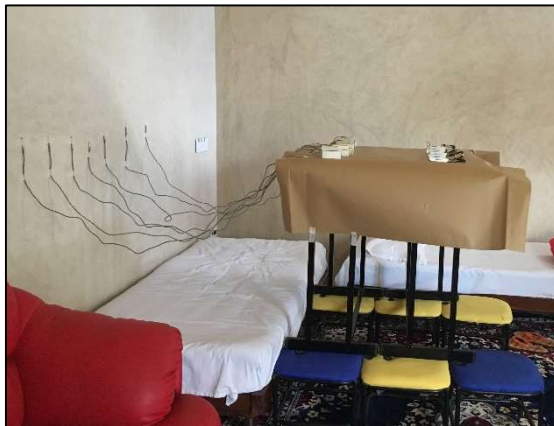
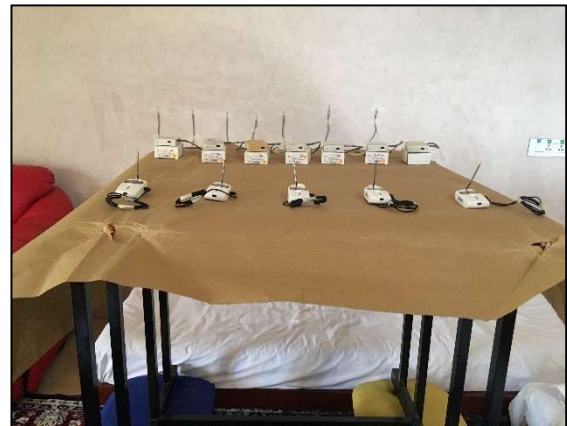
*Figures 4-5 Final distribution of the equipment on the room. (1 HOBO device was added after this picture was taken)*

- 1- Set up all data loggers close to each other, leaving space between the probes (20cm-30cm), in the same room at the same time; approximately 1m – 1.2m above the ground.

- 2- Avoid direct sun and areas under ceiling fans for the location.
- 3- Set the surface temperature sensors on the wall.
- 4- Once everything is setup, send pictures to Transsolar indicating the position of the sensors and a description mentioning their serial number for identification purpose.

Surface temperature values were collected on one of the interior walls of the room, as shown in (Figures 4-5) It is important to note that only 7 of 8 devices collected data, due to the limited availability of sensors. Minimum and maximum surface temperatures recorded are 30.7°C and 31.4°C respectively. In general, all data sets show a similar trend (Graph 8); the highest margin of error between them is only  $\pm 0.1$  Celsius degrees.

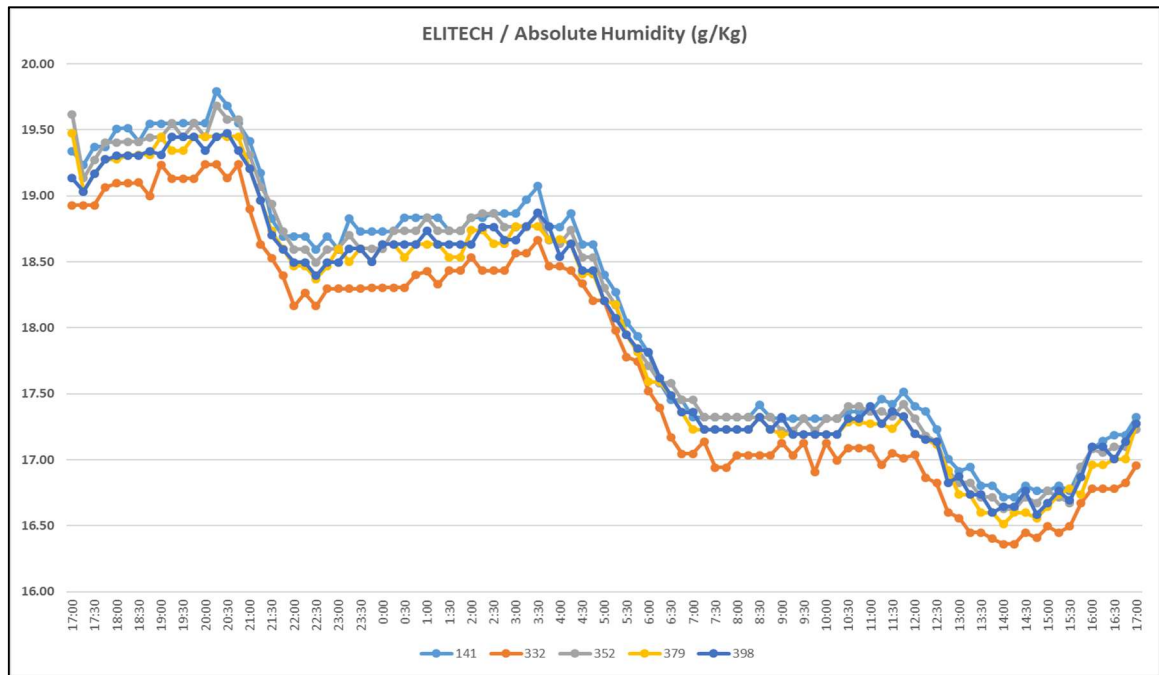
Absolute humidity results are plot on (Graph 3) presenting a similar pattern, with small deviations due to the influence of the air temperature values.

**Graph 3** Elitech devices absolute humidity values

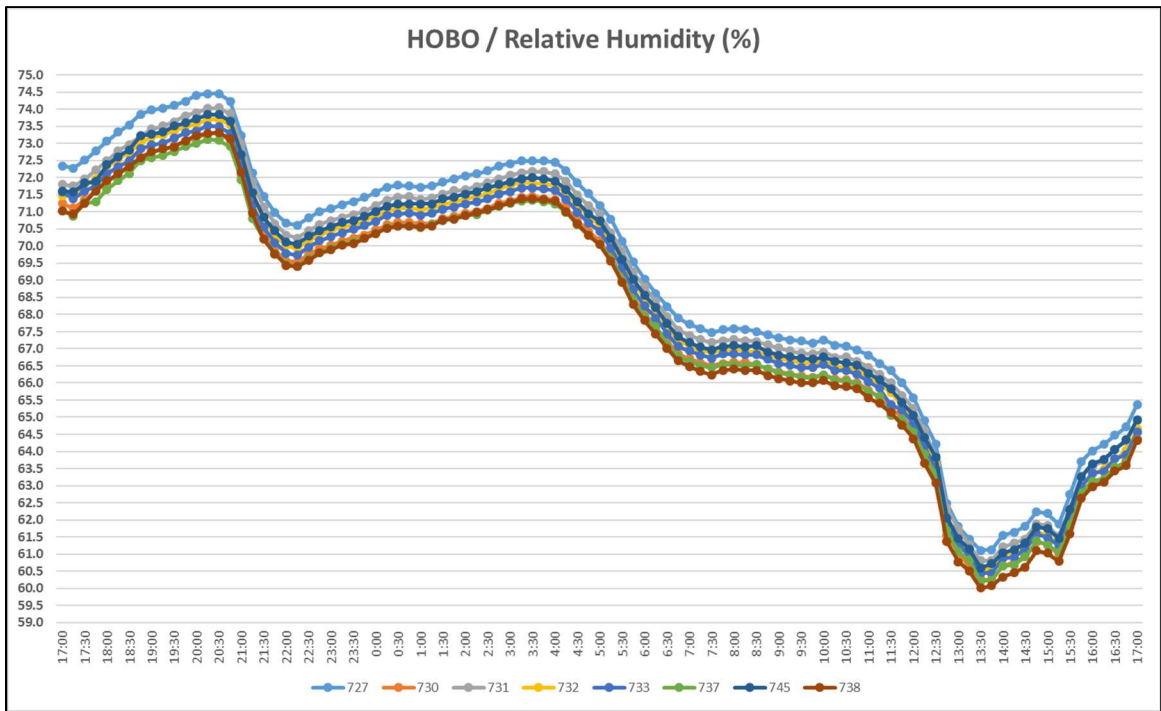
As for the relative humidity levels, results are shown on (*Graph 6*) It should be noted that some deviations appear between devices, in the range of 1-2.5%, which is again not a significant difference, thus it will not be taken into consideration.

Graph 6 HOBO devices relative humidity values

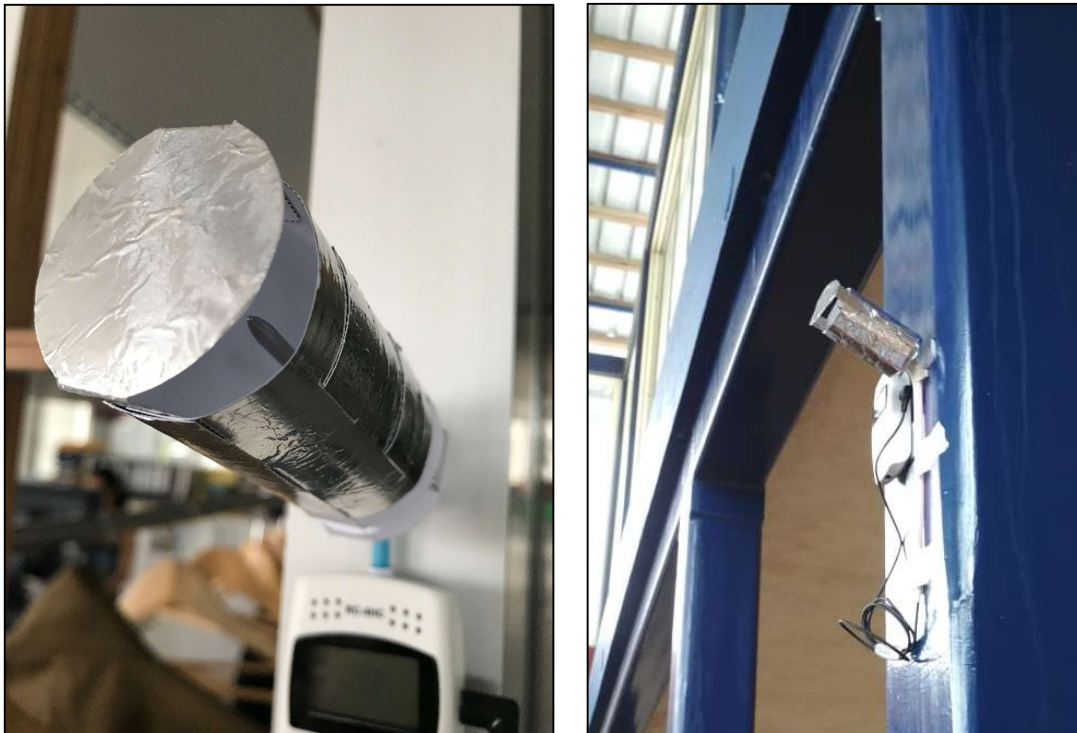
One of the common issues that were found while using the Elitech devices was the vulnerability of its external probe, used for gathering air temperature values. An easy to assemble protection case was designed by the author to provide an inexpensive solution to protect this sensor, conceived to be printed on a thin sheet of cardboard (A4) and built in a few simple steps.

Once assembled, the cylinder provides sufficient space to place the probe, and a constant air flow is allowed thanks to the ventilation openings located at the top and bottom. Covering the outer surface of the case with a thin layer of aluminum foil, which can be found in any kitchen, adds additional properties of light reflectivity.

*Figure 12-13 Prototype built by the author, notice the probe inside (left), and its application in the building*

Auroville Language Laboratory personnel was able to build all the needed prototypes, which demonstrated the applicability of the idea. However, it is important to mention that only theoretical assumptions were considered for its conception, thus an analysis of its real performance remains a work in progress. In addition, its use is recommended only for indoor spaces as the materials and the design are not suitable to offer protection against rain or strong winds. The template can be found as an annex at the end of the document.

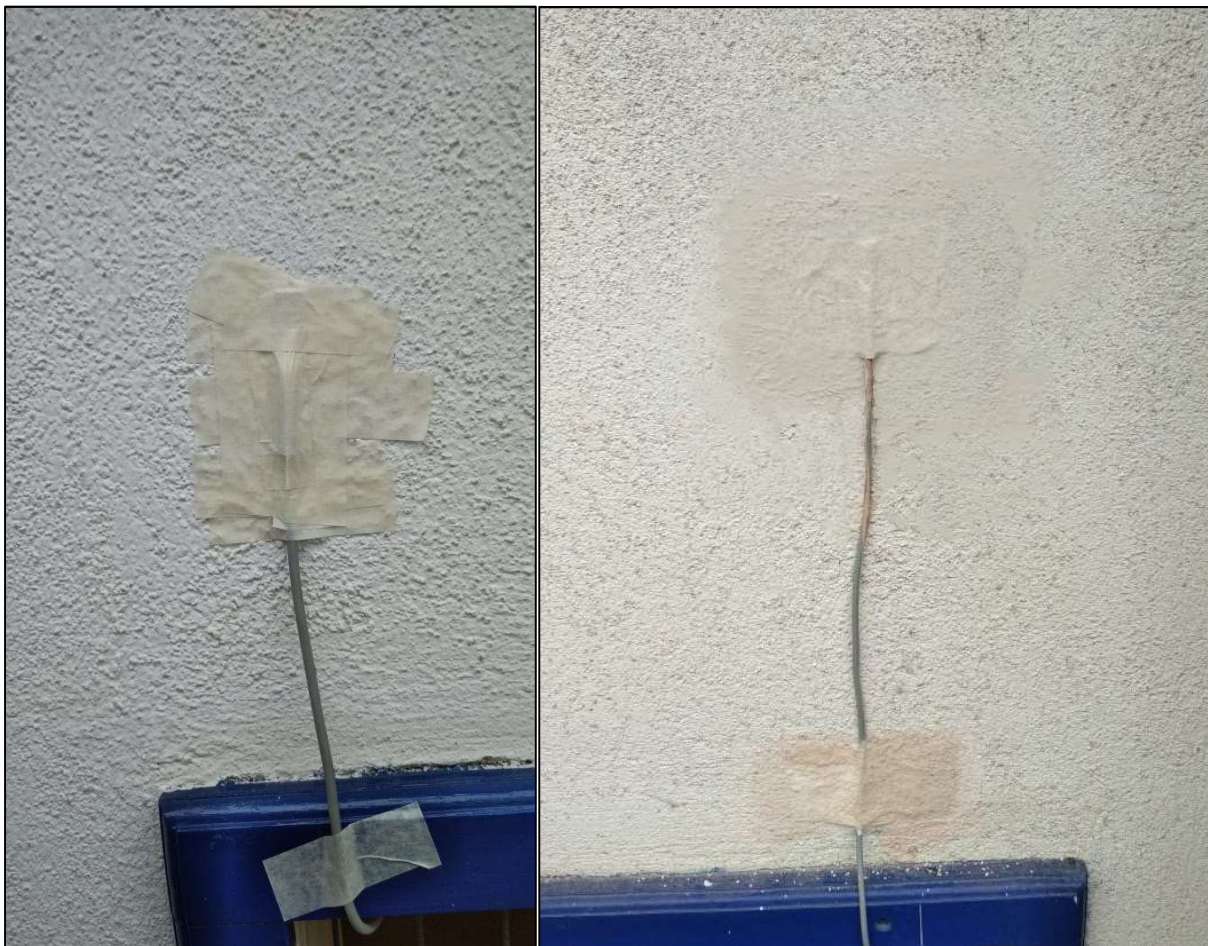
As the predominant material in the building is lime, it was decided to fix the sensors to the surface using layers of masking tape, which were subsequently covered with a solution of lime plaster. The masking tape has a high thermal transfer, so its insulating properties are relatively low especially compared to other adhesive materials. This, together with the applied lime paint, allowed to obtain a coating similar to that of the façade.

*Figure 14-15 External surface temperature sensors before and after applying the lime paint protection layer*

Initially, the possibility of placing them in a shaded area under the overhangs was considered. However, the length of the cables and the fact that this location was not optimal for our measurement purposes were major drawbacks that led to the rejection of the idea.

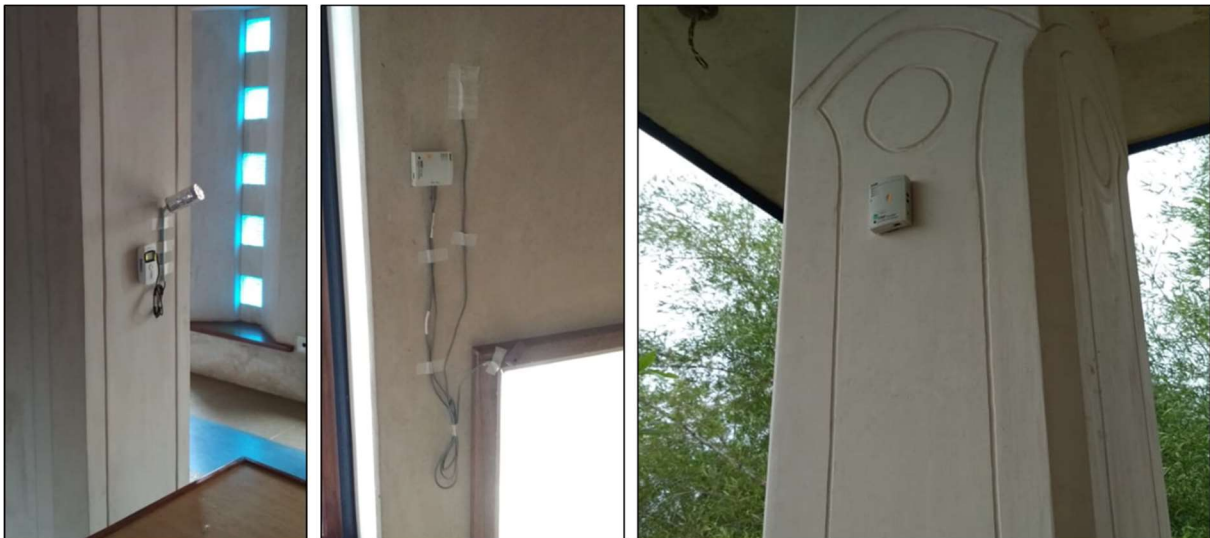
*Figure 16-18 Final setup for equipment. From left to right: Adults Passive, Indian Class and Outdoors*

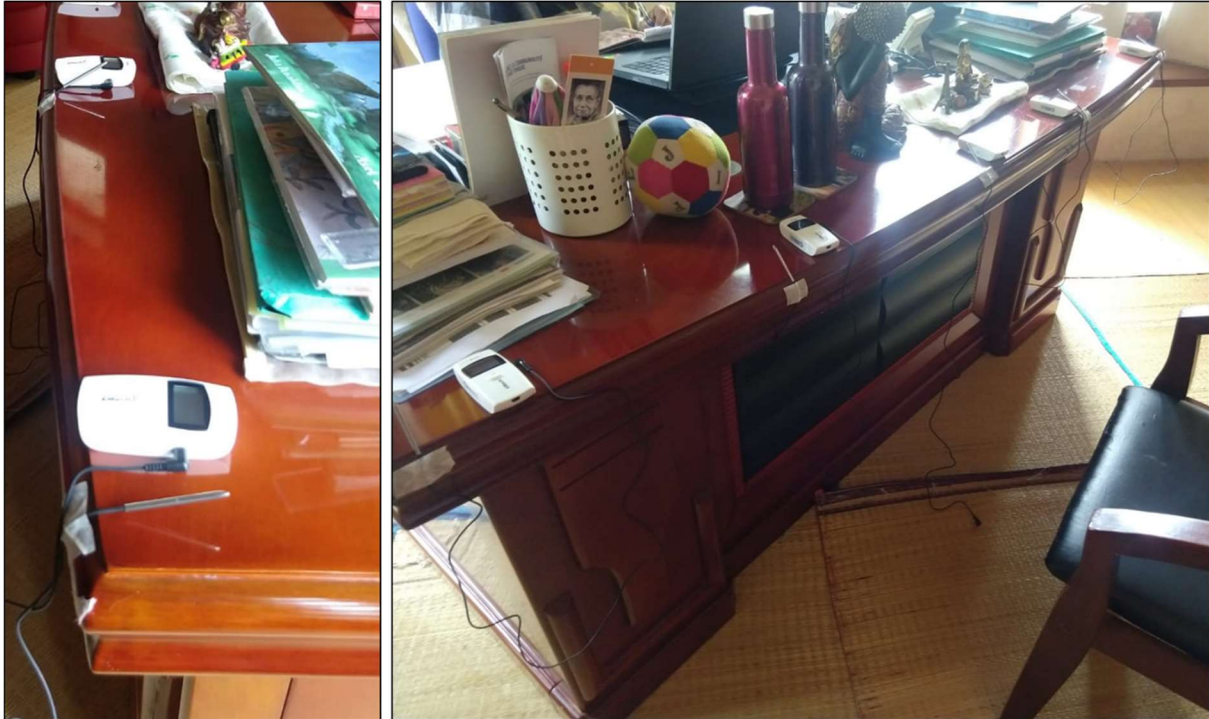
*Figure 19-20 Setup used for the first three attempts. Previously mentioned issued can be easily recognized*

- A detailed explanation was given to clarify how to set the basic parameters of the data loggers in the software.
- Photographs showing the position of the equipment were requested. These showed that the cause of the incoherent behavior between devices was due to a bad positioning of their external sensors. These had been placed on a table, very close to its surface, contrary to what was specified in the methodology. Instructions were given on how to properly place the sensors.

- Instructions were given to move the devices into an unoccupied room, with the objective of minimizing external factors that could influence their performance.

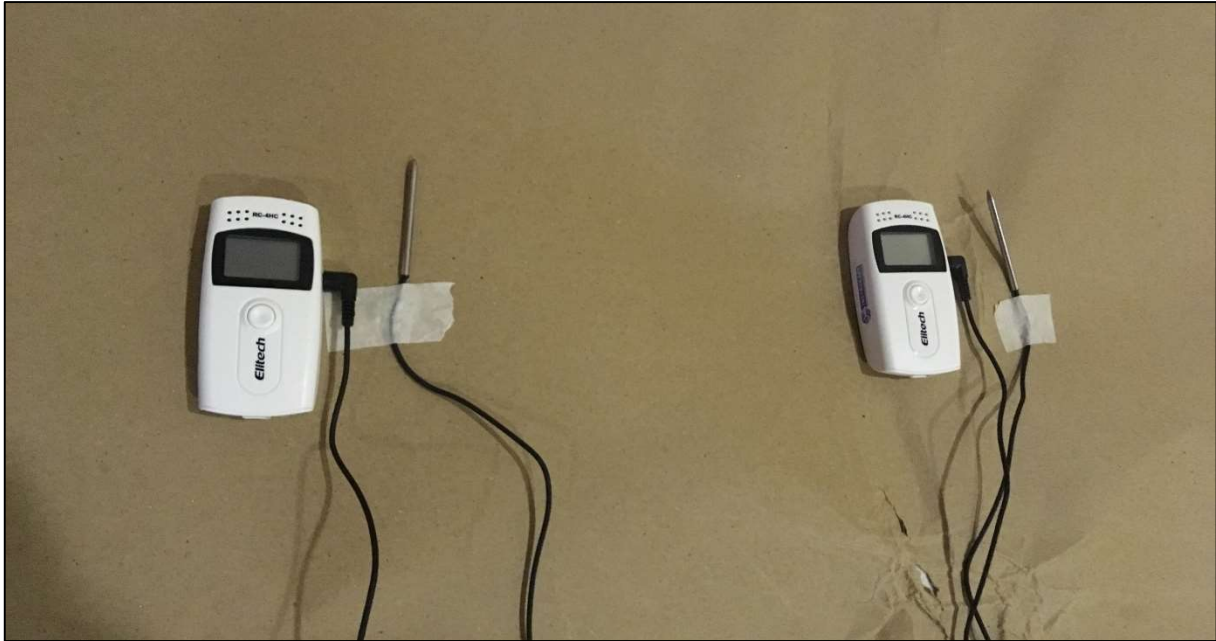
*Figure 21 Incorrect placement for the Elitech devices external sensors*

- A new video call was arranged to explain in detail the proper way to place the equipment.
